SPECIAL AIRWORTHINESS INFORMATION BULLETIN

SW-06-65
August 22, 2006

This Special Airworthiness Information Bulletin (SAIB) alerts you, owners and operators of **Eurocopter Deutschland GMBH (ECD) Model BO-105 series helicopters**, of the potential for a tail rotor pedal cover installation error that could result in limiting and/or binding of the anti-torque control pedals. This installation is predominately in the Air Medical operations but could be utilized in other operations. This SAIB may also apply to other aircraft installations where a box cover has been installed.

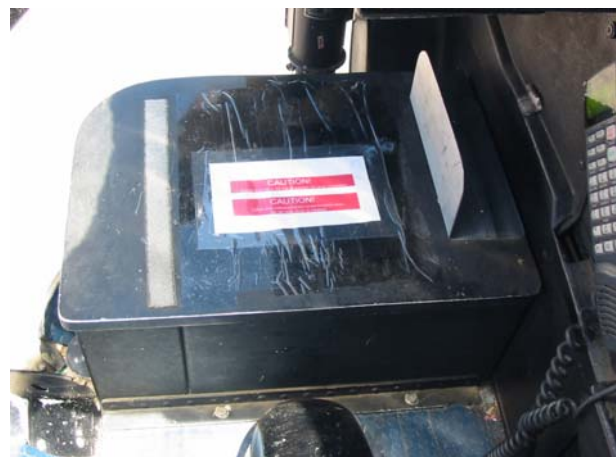
Photo 1.1

During a recent accident investigation it has been determined that the potential for the installation of a field approved anti-torque pedal cover "box" (see attached photos 1.1 & 1.2) may limit anti-torque control pedal input and could result in the loss of aircraft control.

- Remove the field approved tail rotor pedal box and install a supplemental type certificated (STC) tail rotor pedal safety kit.
- Review the tail rotor pedal cover installation instructions on the field approval in the aircraft maintenance records. The pedals **MUST** be moved to the **FULL AFT** position. (AFT is

considered the position toward the back of the aircraft)

- Have the installation and removal performed by a licensed airframe mechanic.
- Ensure your tail rotor pedal cover box is clearly marked per the FAA form 337. The field approved FAA form 337 for this installation states: "CAUTION! The pedals must be in the full aft position for cover installation" and "CAUTION! Cyclic and collective covers to be installed when the tail rotor pedal cover is installed" and "both placards must be Red with white letters and located on top of the pedal cover."
- Pilots should perform a full anti-torque control pedal full movement check as part of their pre-flight inspection.
